DEPARTMENT OF THE ARMY
ARMY CONCEPT TEAM IN VIETNAM
APO San Francisco 96384

FINAL REPORT

MILITARY POLICE RIVER/HARBOR SECURITY COMPANY

ACTIV PROJECT No. ACG-73F

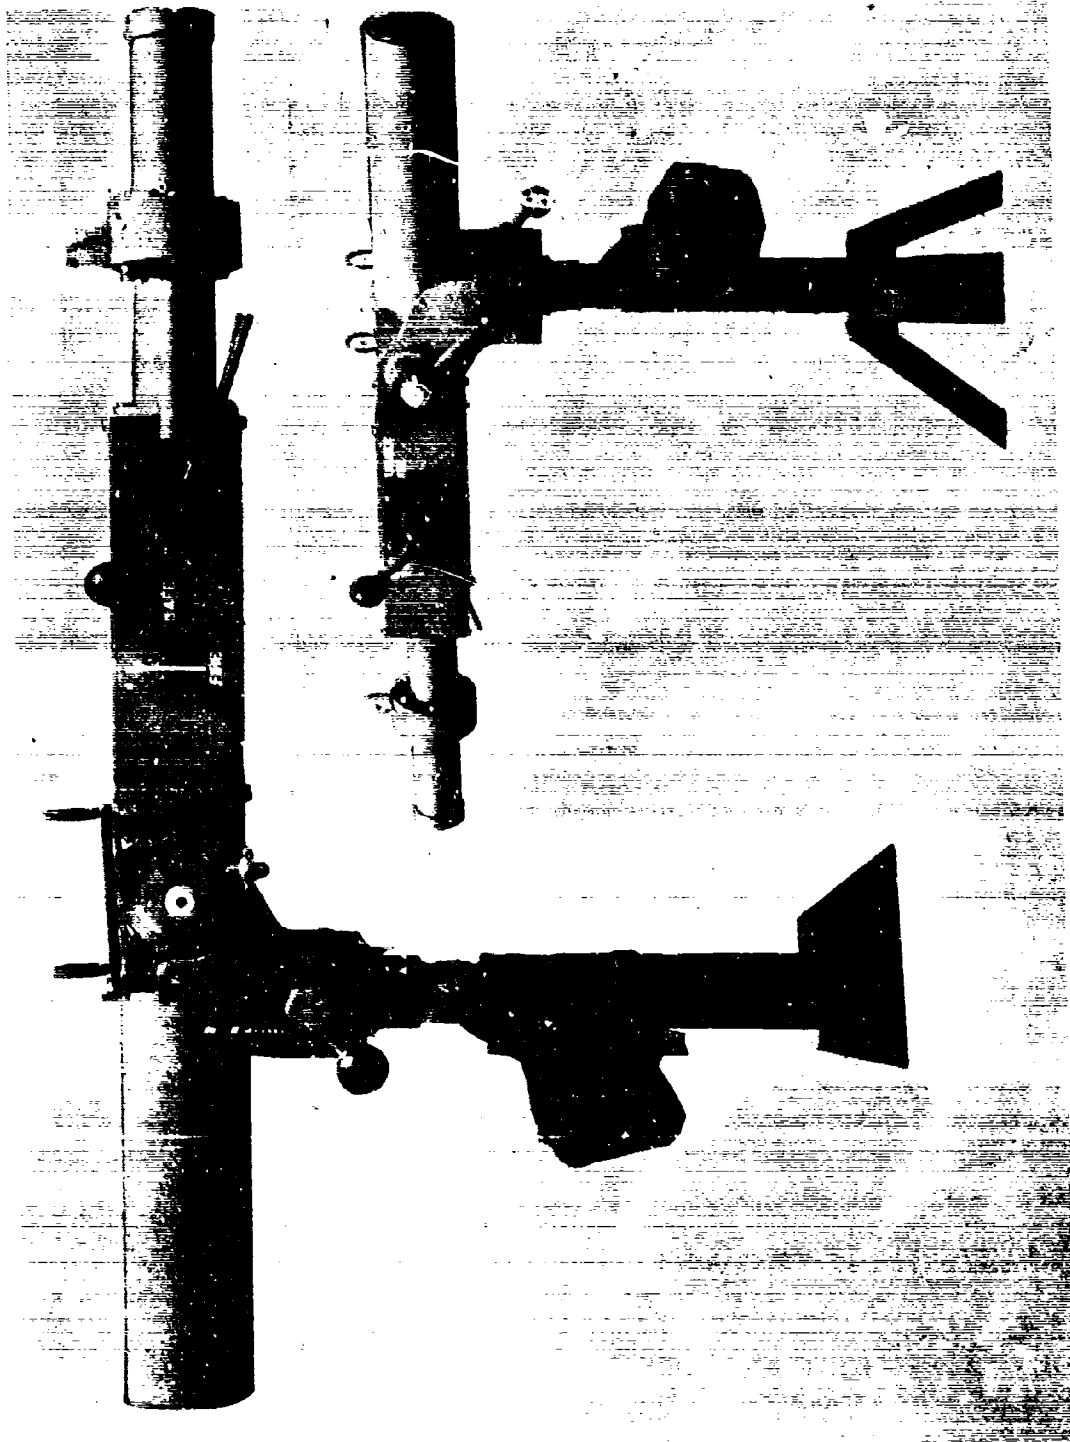
FIGURE II-17. 60mm Naval Mortar on Gun Pedestal.

5. One outpost obtained a US Navy 60mm mortar (see Figure II-17) and mounted it on the aft emplacement of the PBR. This weapon can be drop-fired or trigger-fired, and used for both direct and indirect fire.

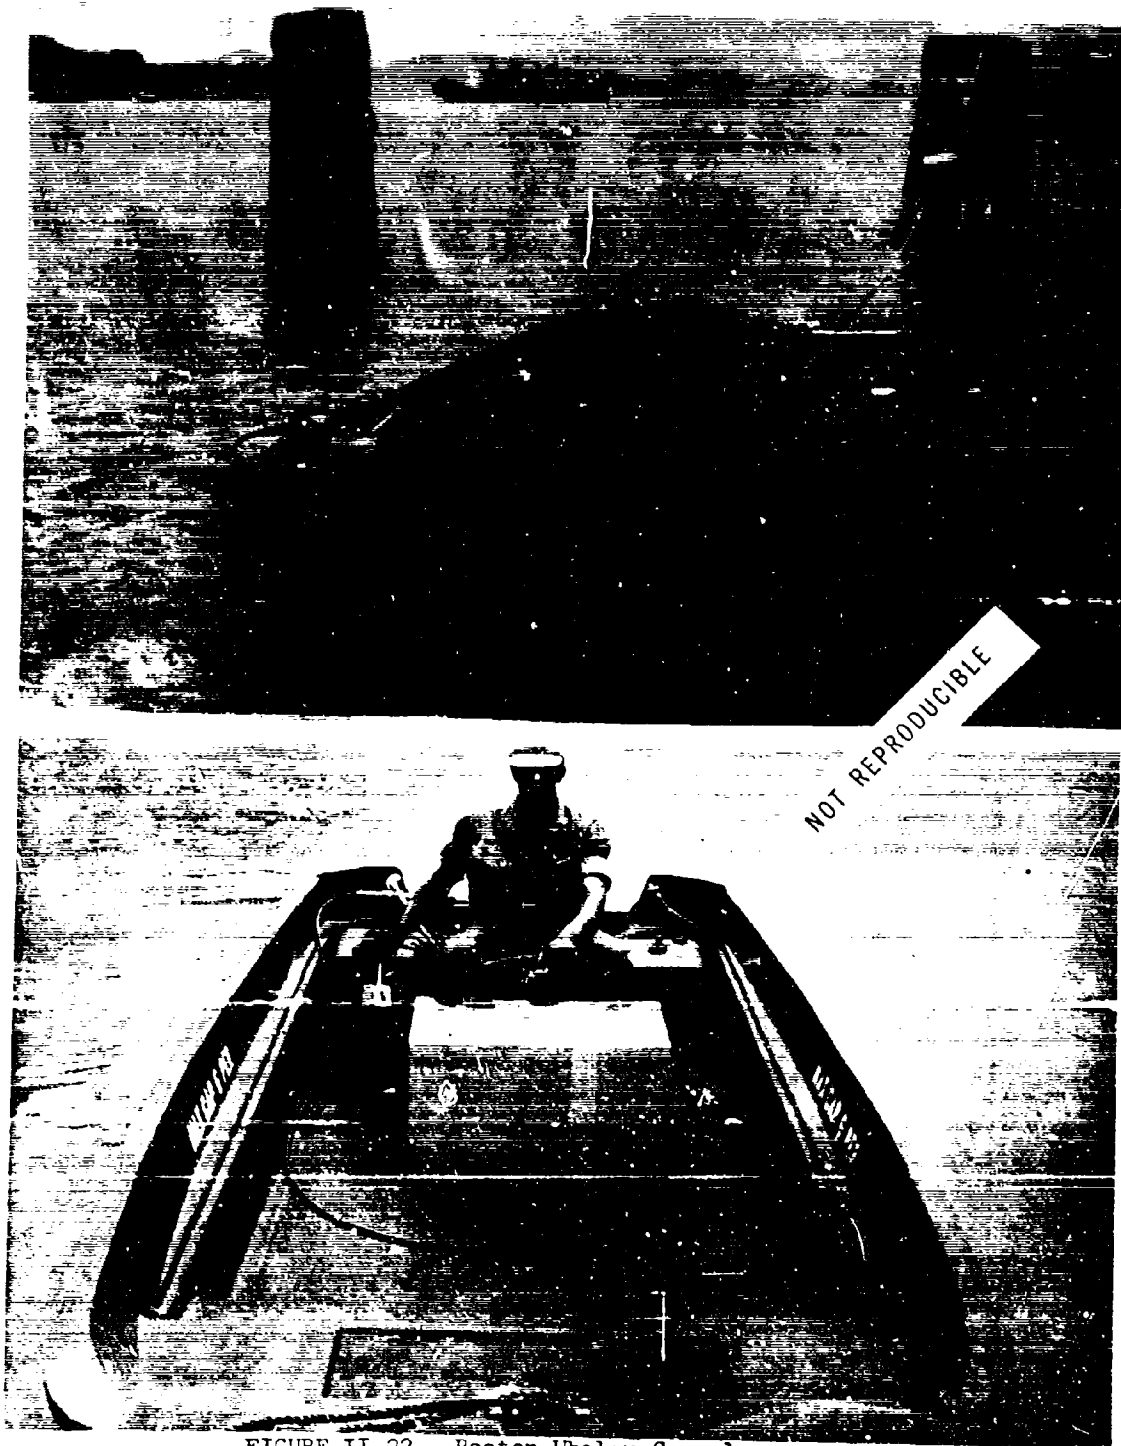
FIGURE II-22. Boston Whaler Consoles.

All personnel interviewed stated that the BW was generally satisfactory for the assigned missions. Its only limitation was imposed by rough water. The only modification to the boat design was the installation of an improvised control console (see Figure II-22). Some crew members also recommended a design change to reinforce the rim around the top of the boat.
